Fukushima Daiichi –

nuclear disaster

Avtor: Gabrijela Ikovic

Jedrska tehnika in energetika 2012/13

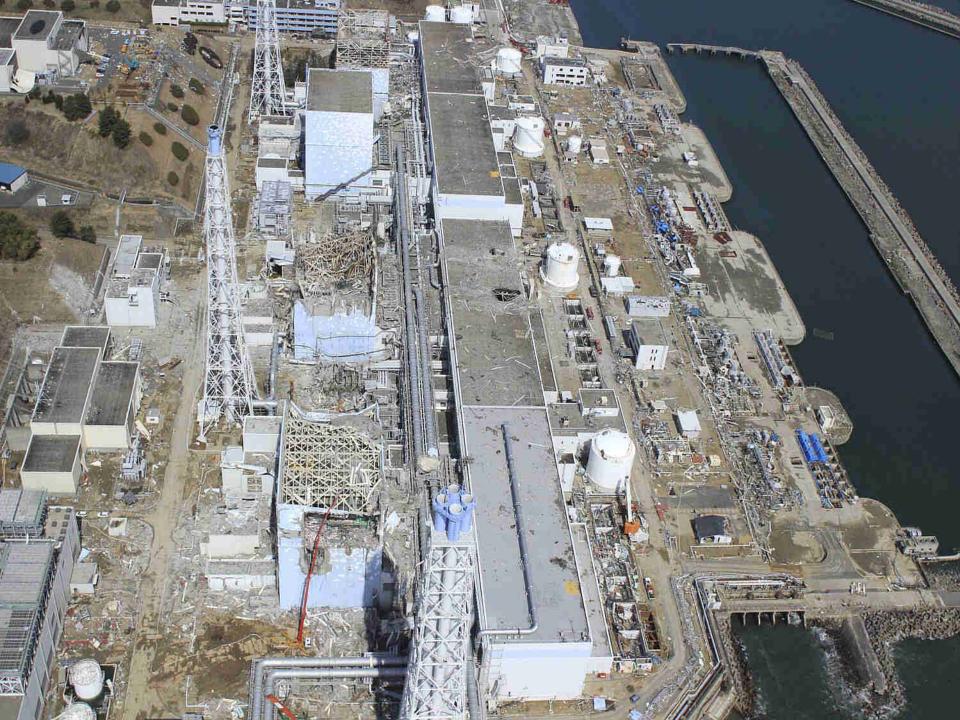
destroyed diesel backup power systems

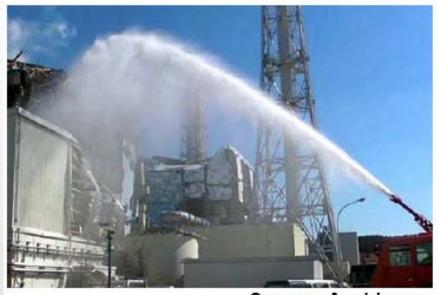
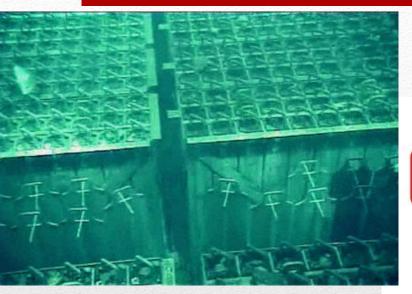
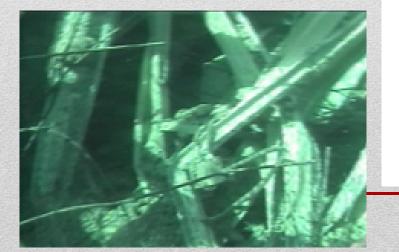
First few weeks:

Cooling with external water cannons (#1 & #4) – 2 weeks sea water, later fresh water

Structural integrrity of pool #4 was questionable – explosion(H2 from unit#3)

Pools #2 and #3 – standard cooling system (8.5.2011)

Pools of unit #5 and #6 and main pool: cooling systems were working normaly all the time

Temperatures: 30-40 °C
